Accessibility of Two Bus Stops in the Charlotte Area

Jordan Pleasant

Public Transportation 637

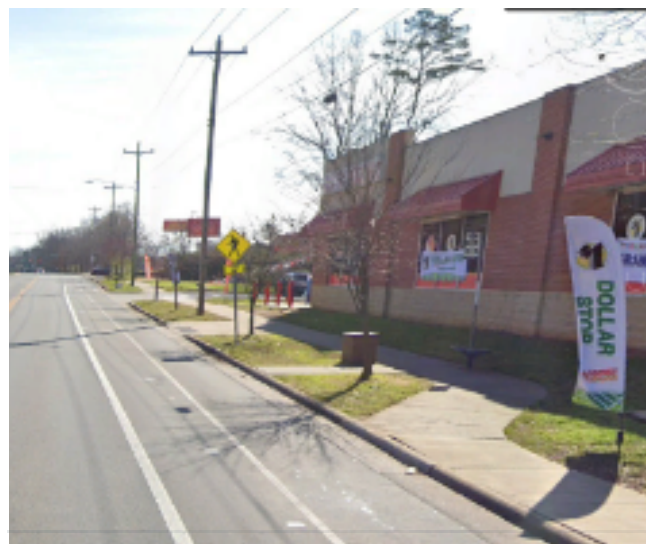
on Milton Road (Figure 6) a 4, and for Resting Spot, I gave the bus stop a 5. The stop scores a 4 for visibility because the side of the shelter are translucent instead of fully transparent. Resting spot scores a 5 because there is a nice shelter, with separated bench seats, a lean bar, and a spot for a wheelchair user to rest. I considered these indicators to be not applicable for N. Sharon Amity.

Both streets also score average for lighting. The streetlights are roughly every 100 feet, and the shelter is 50 feet from the nearest streetlight. Lighting is not awful, but it could certainly be a lot better, thus the 3 scores.

For the shelter in Figure 6, I would recommend adding some solar-powered lights within the shelter. The shelter is 50 feet away from the nearest streetlight and greatly needs interior lighting.

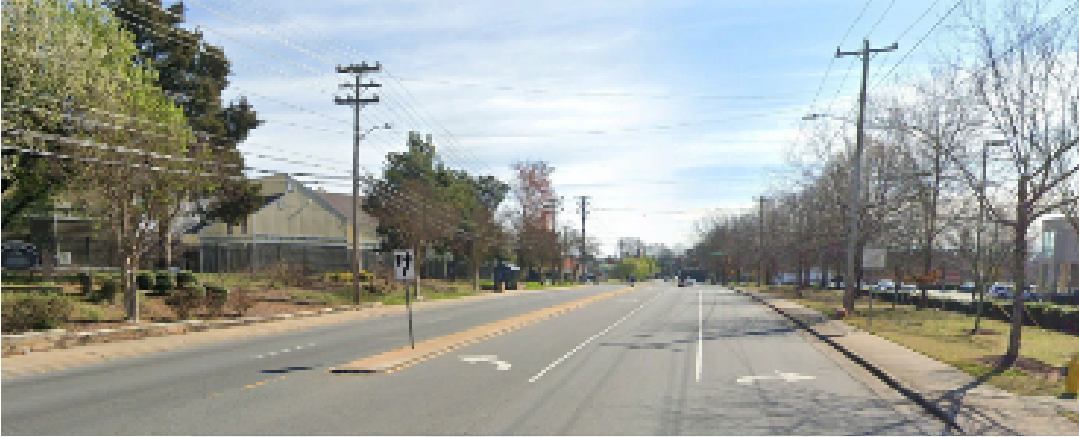
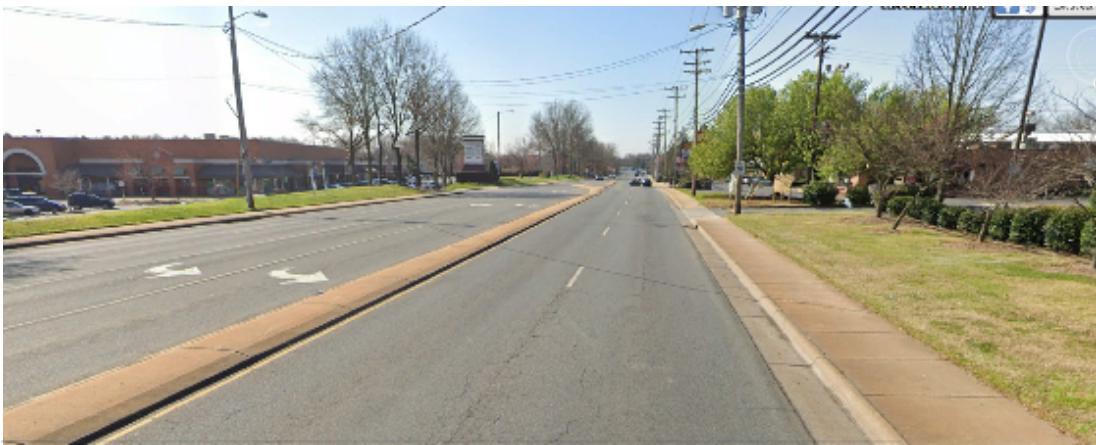
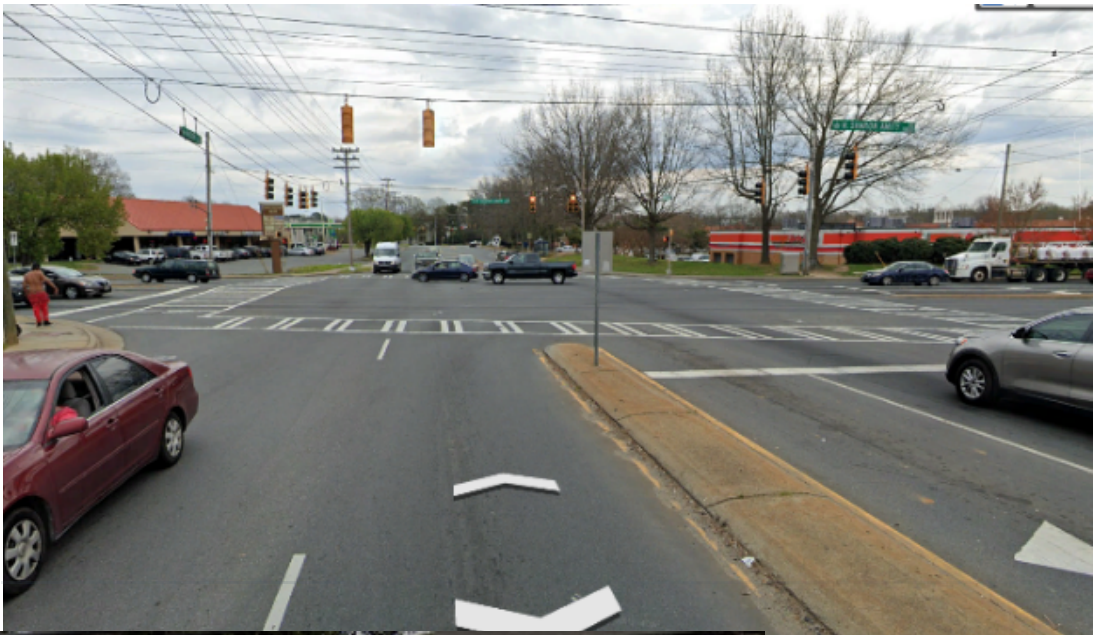
For traffic buffering and traffic speed, both streets score low. Milton and Sharon Amity have essentially zero traffic buffering, as you can see in Figures 2 and 3. There is a 40-foot span on Milton (Figure 1) that has grass between the sidewalk and the street, which is the only reason it scored a 1.5. For traffic speed, both streets have a 45-mph speed limit, realistically meaning that vehicles are going at least 50 mph. This is not a survivable speed for a pedestrian to be struck at (Sadik-Khan).

leaves. But the trees are spaced at fairly regular intervals (Figures 1-5). N. Sharon Amity has less tree cover than Milton, which is why it scores lower.

I have a few simple recommendations for the Milton Road/N. Sharon Amity Road area. In Figures 2 and 3, there is a wide stretch of flat grass beside the sidewalk. In these figures, I would recommend repaving the sidewalk further away from the road and replacing the former sidewalk with grass and trees. This creates traffic buffering and would greatly improve pedestrian comfort. You could do something similar for the side of the street represented in Figure 6, but it would require a good deal of grading and would be more costly than the recommendations for Figures 2 and 3.

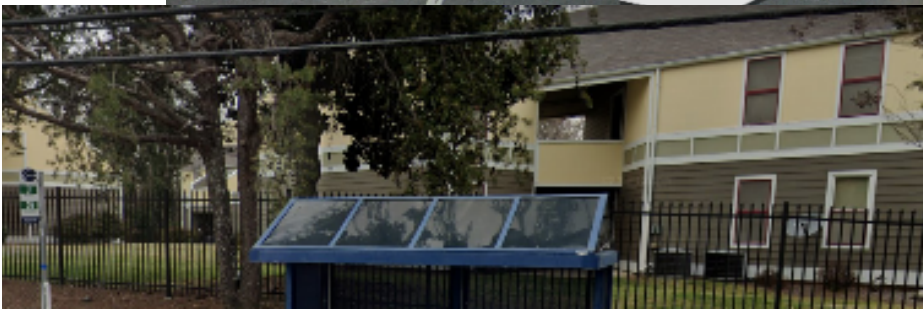
For crosswalks (Figure 4) the streets get relatively high marks. While it is a very wide intersection, the crosswalks are well marked, have crossing buttons, and all have pedestrian signals.

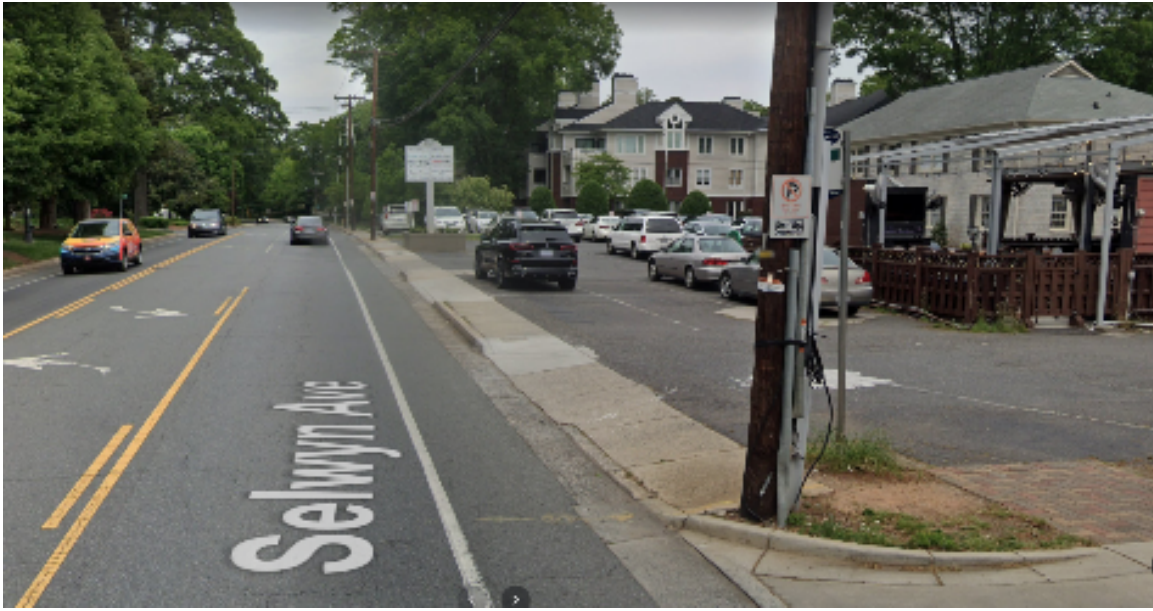
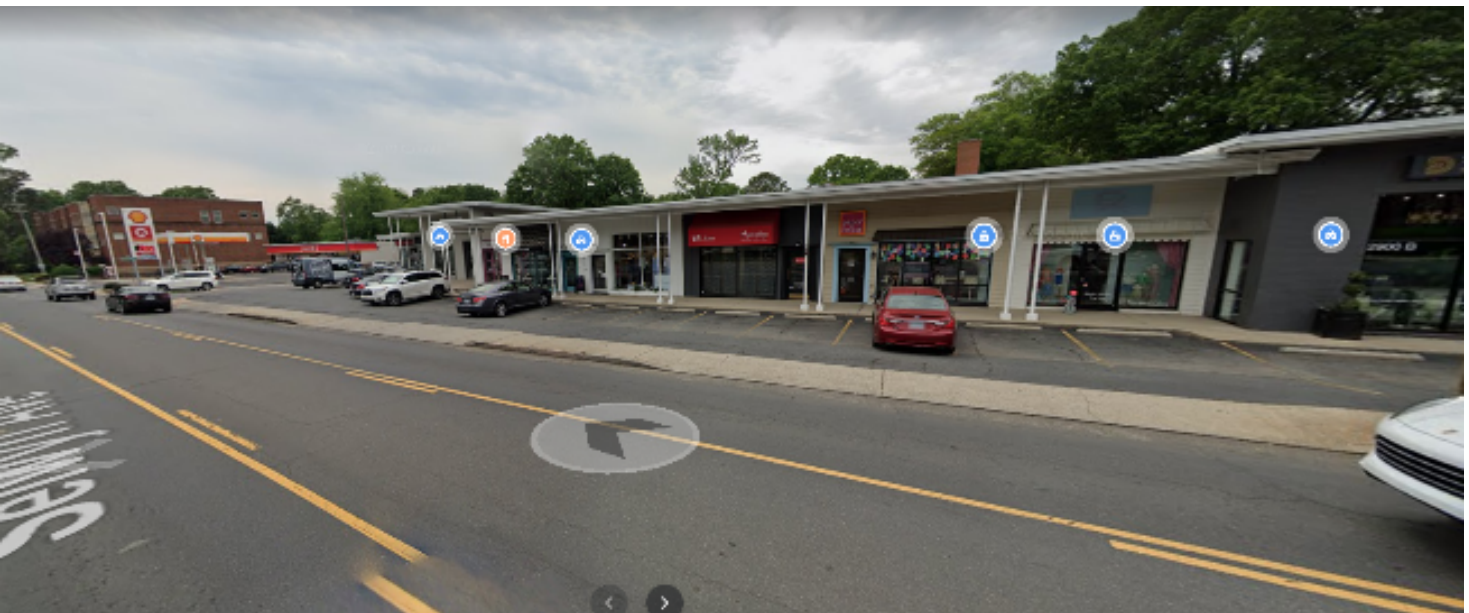
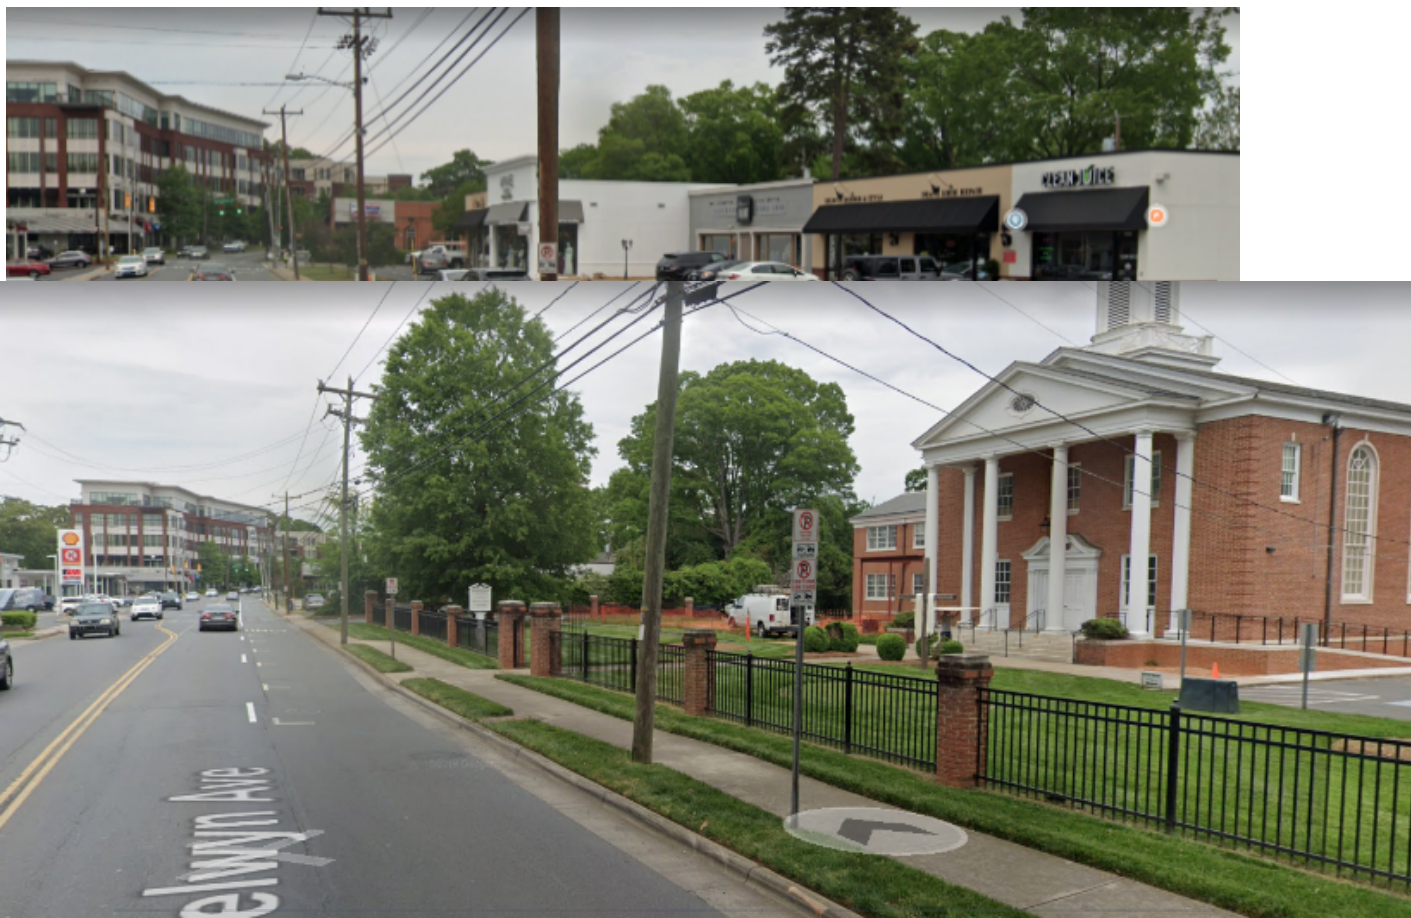
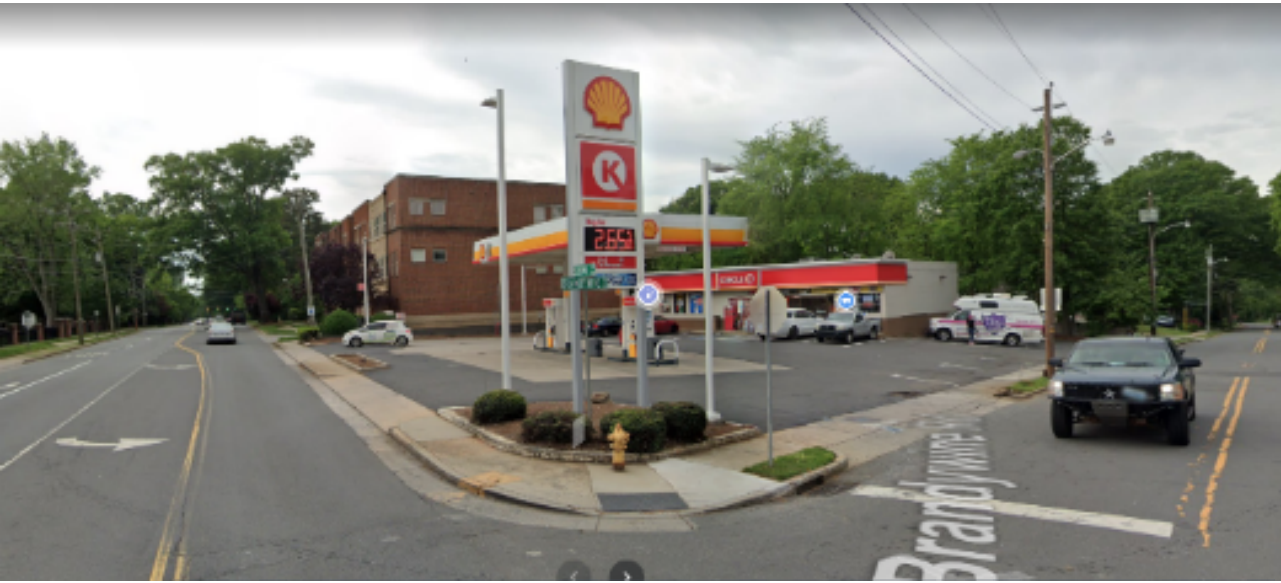
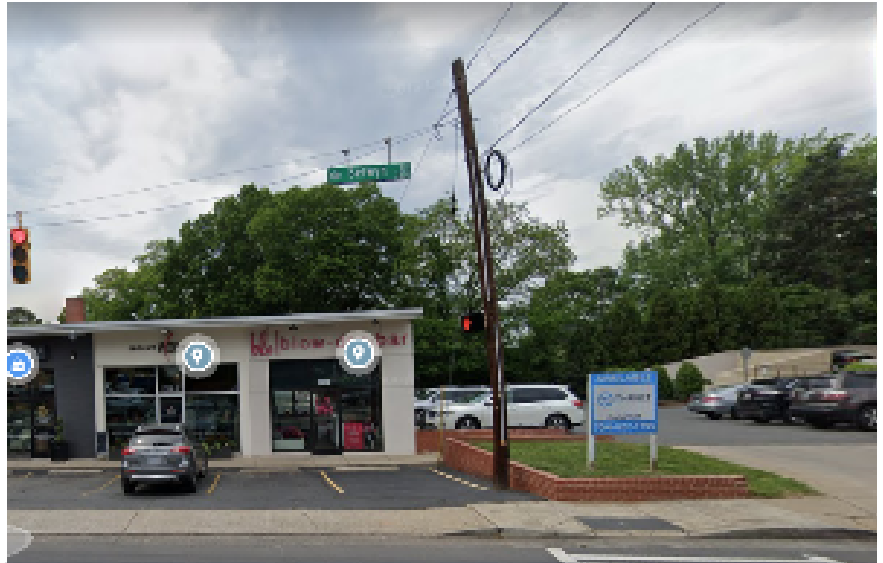
Selwyn north was scored as a 4.5 for Traffic Buffering. Figure 8 shows that the sidewalk is several feet from the roadway, with planted trees, shrubs, and the occasional power pole in between pedestrians and vehicles. Similarly, Figure 9 shows a lot of trees and a grass strip to protect pedestrians. The only reason it does not score a 5 is because of Figure 10. There's zero buffering, and half of the "sidewalk" is just a driveway apron for cars.

Selwyn south scores a 1.5 for buffering. Figures 11, 12, and 15 are why it scores so low. In Figure 11, Similar to Figure 10, those 3 Figures show how there is zero buffering, and half of the sidewalk tilts towards the street. These are extremely unsafe conditions for pedestrians. Figures 13 and 15 save the street from getting a zero score. Figure 13 at least has some grass, and Figure 14 is well set back. Selwyn north and south both receive a score of 3 for traffic speed. The speed limit is 35, which is fairly moderate, and there is a traffic light which further slows it down.

The two directions of Selwyn have very different Use scores. North gets a 4.5, because it is an area highly patronized by pedestrians. It does not get a 5 because of Figure 10, where very few people walk. South gets a 1.5 because it is rarely in use by pedestrians, except in front of the apartments in Figure 15.

Selwyn north has trees and buildings to provide shade. It scores a 4 because of Figure 10, where there are no trees. Selwyn south scores a 2 for Trees/Shade. Figures 11, 12, and 15 have no trees. However, there is slight tree coverage in Figures 14 and 13, saving the street from a score of 1.

For Universal Design, Selwyn south scores a 1. Figures 11 and 12 could easily spell disaster for someone in a wheelchair, who could potentially slide into the street or tip over. Figure 12 has power poles in the center of the sidewalk, as well as a USPS drop box and a pile of rocks. A wheelchair does not have sufficient space to get around the power poles, drop box, and rock pile. Someone with visual impairments could walk into several of these obstacles shown. The crosswalk button in a parking spot is also highly dangerous for the mobility and visually impaired. Selwyn north, however, scores a 4. There are wide sidewalks and they are well lit. Someone mobility impaired can easily use these sidewalks. The only reason north does not score a 5 is because of Figure 10.

For lighting, Selwyn north scores a 4.5. There are pedestrian scale street lamps, exterior lights on the buildings, and the stores inside all light up the space well, allowing excellent visibility. Figure 10 once again prevents Selwyn north from a score of 5. Selwyn south has zero streetlights, but there are at least some businesses to shed a little light on the path, and the apartment complex in Figure 14 is well lit.

- In Figure 16, the crossing button needs to be moved to the corner of the bricking. This takes it out of the parking spot and improves safety.
- In Figures 10 and 12, the power poles need to be taken out of the sidewalk. The USPS drop box also needs to be moved, and the small rubble pile needs to be cleared.
- Figure 12 has plenty of space to move the sidewalk further away from the street, and replace the former sidewalk with at least grass and perhaps trees.

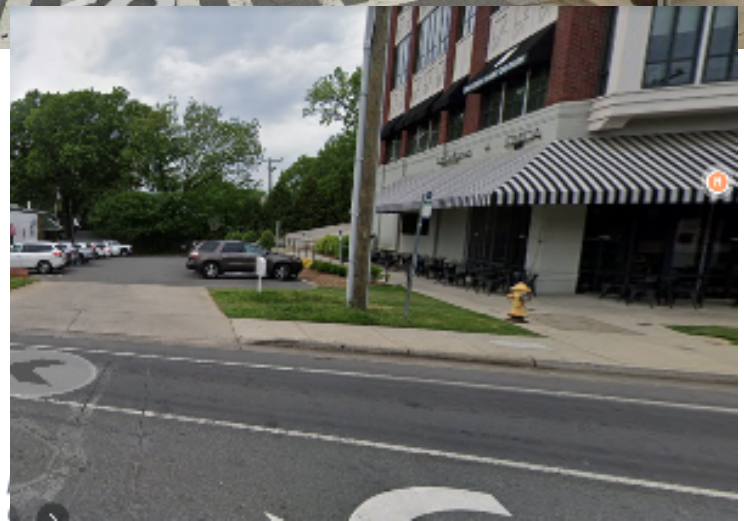
Figure 18 shows the reason that Passenger and Driver Visibility was scored as a 4 on Selwyn north. The bus stop is very open, and both passenger and driver can easily see the other. Selwyn south was not scored, because that stop only serves buses coming from the north.
